**Type A Accident
Investigation Board Report
of the February 13, 1997
Welding/Cutting Fatality
at the
K-33 Building, K-25 Site
Oak Ridge, Tennessee**

1.0 INTRODUCTION

1.1 BACKGROUND

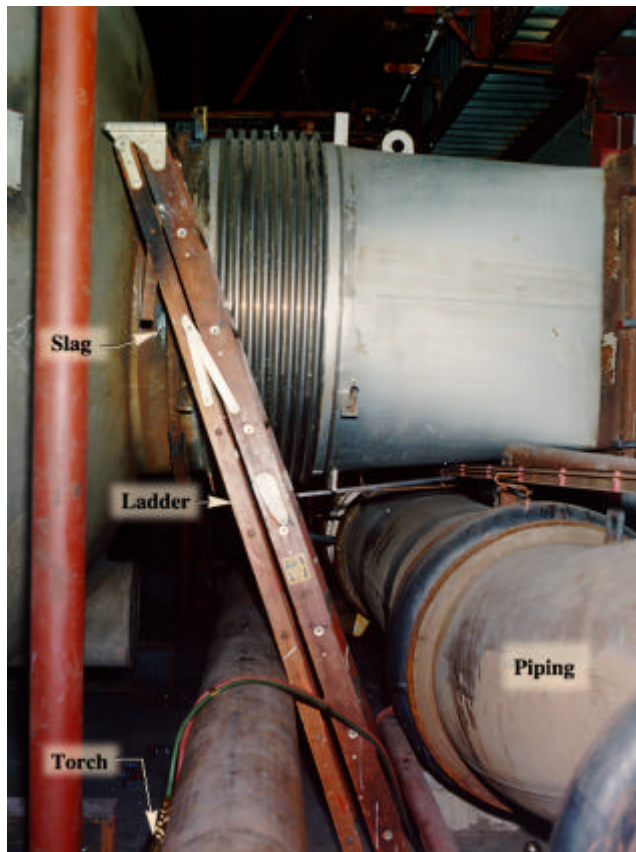
Exhibit 2-2. East End of Converter 4

The Welder was using a cutting torch to remove one of the six remaining process converters and, at the time of the accident, was working on a ladder at the east end of Converter 4 (see Exhibit 2-2).

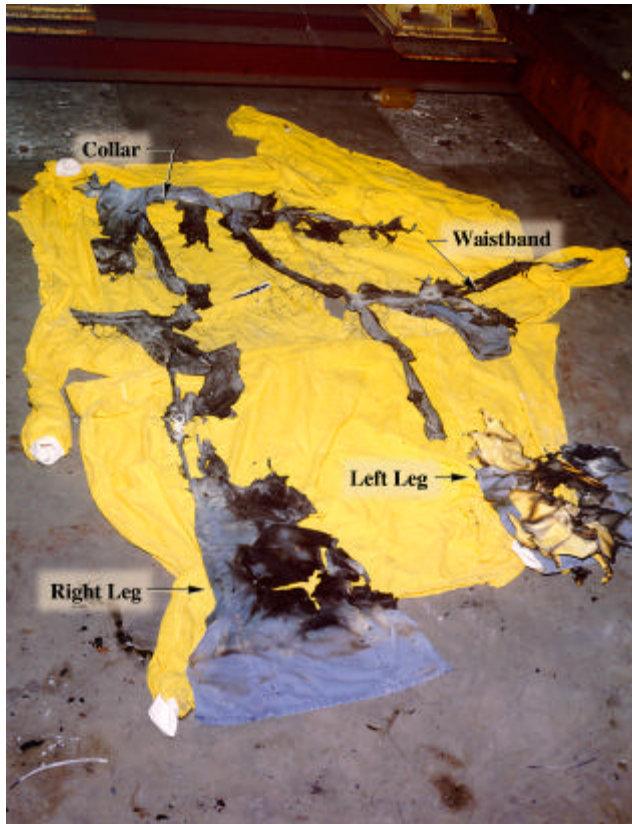
Results of the burn tests revealed that very high temperatures were attained quickly on the outer layers of the anti-contamination clothing, while the temperature at the skin level remained nearly the

The outer anti-contamination coveralls do not provide protection from fire.

same. The multiple layers of clothing effectively insulated the Welder from the heat and seriously impaired early detection of the fire. The burn tests also indicated that the anti-contamination and general-purpose coveralls worn by the Welder and other K-25 LMES welders did not, by themselves, provide any fire protection as personal protective equipment for the hazards of cutting, welding, and other hotwork. The flammability characteristics of the anti-contamination clothing made this clothing inappropriate for the cutting and welding operations being conducted at the time of the accident.
